DEBRIS/ICE/TPS ASSESSMENT  
AND  
PHOTOGRAPHIC ANALYSIS  
OF  
SHUTTLE MISSION STS-32R

January 9, 1990

Gregory N. Katnik  
NASA/Kennedy Space Center  
TV-MSD-22

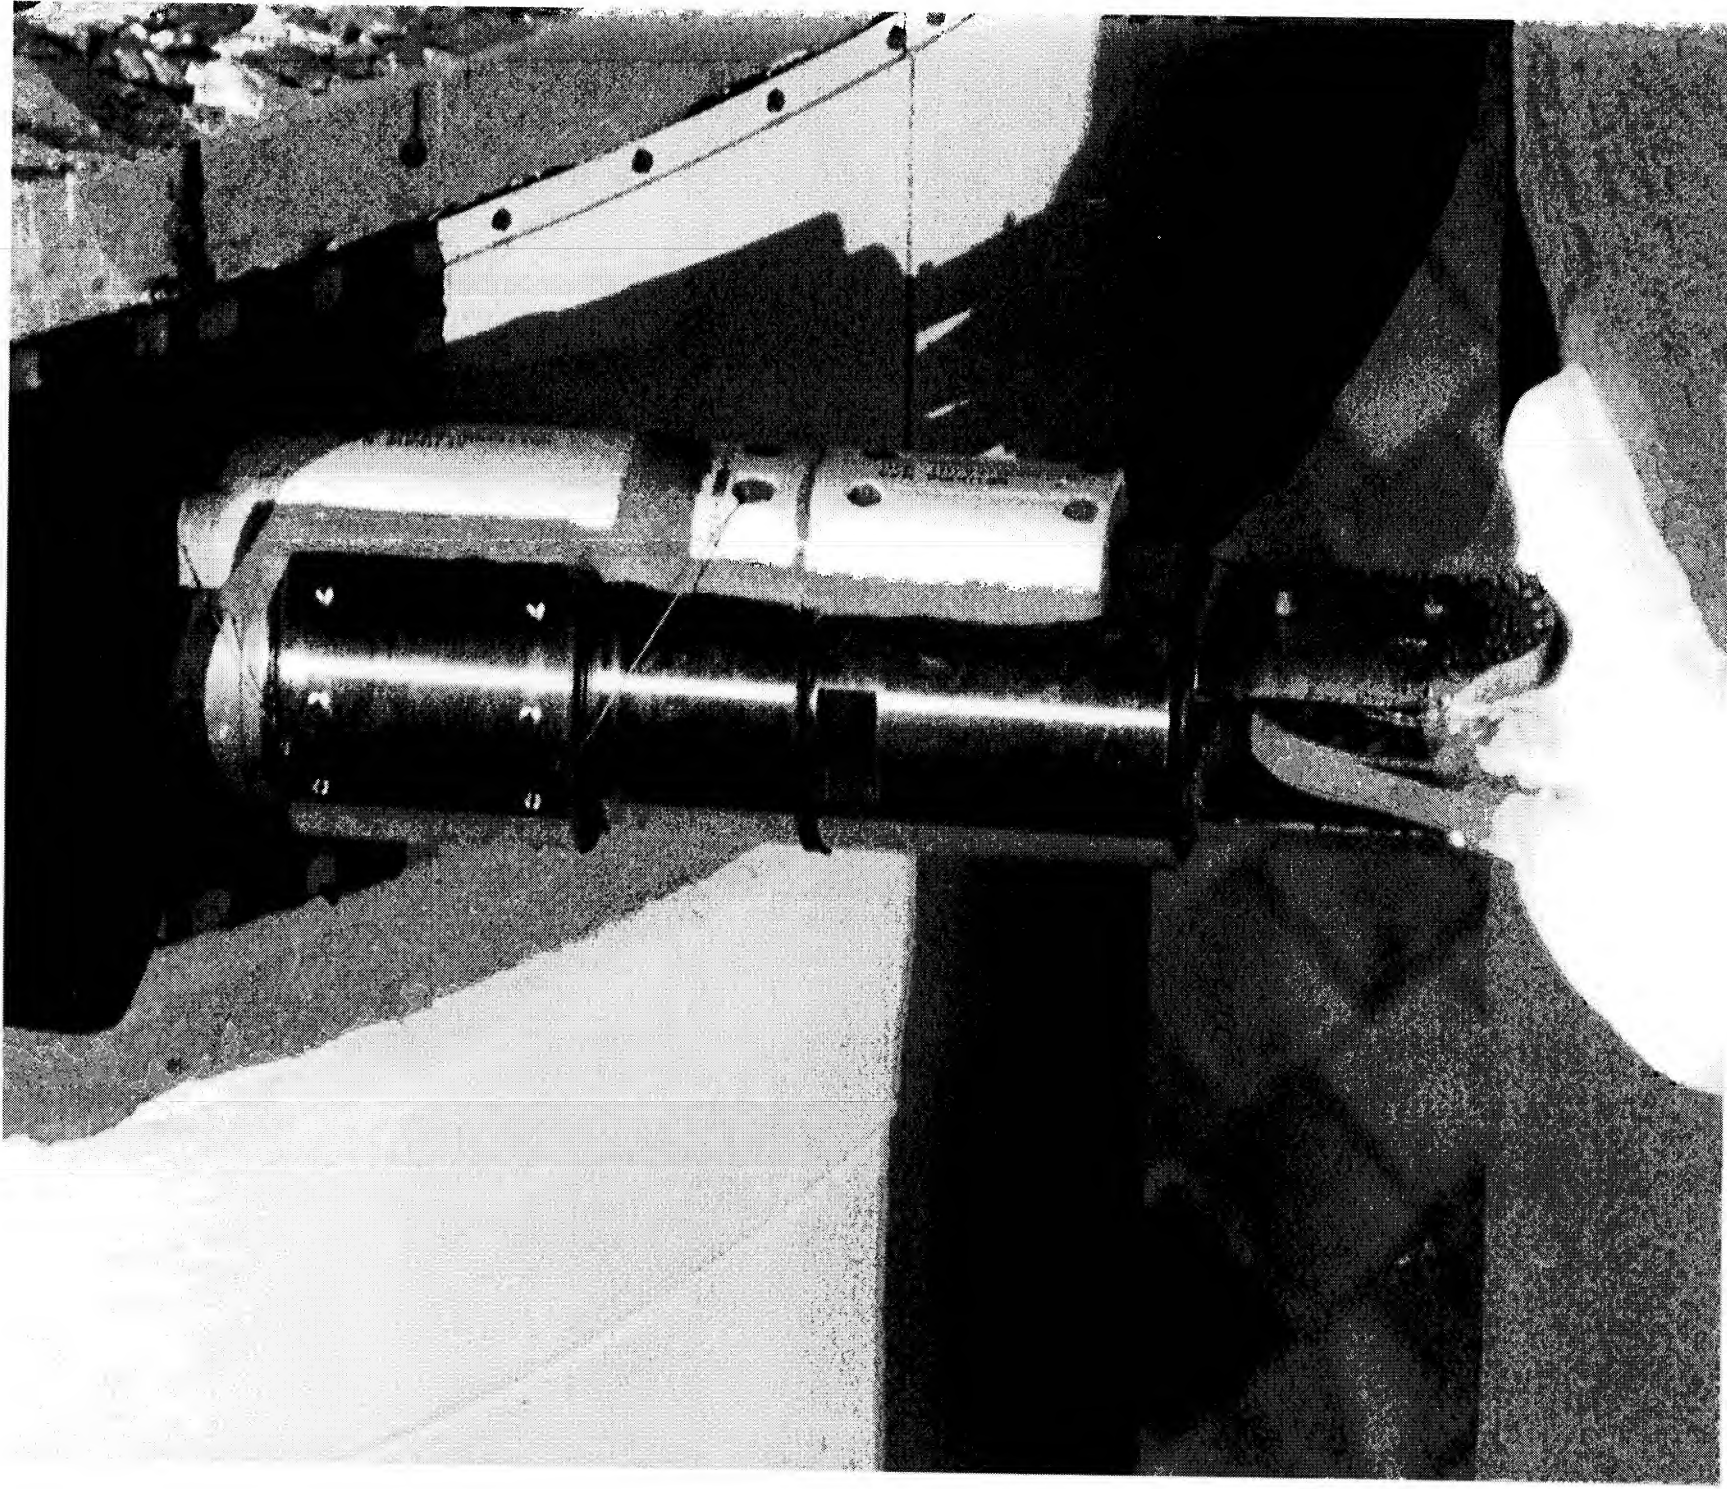
Although ice/frost covers the EB-7 fitting, only condensate is present on the lower strut clevis

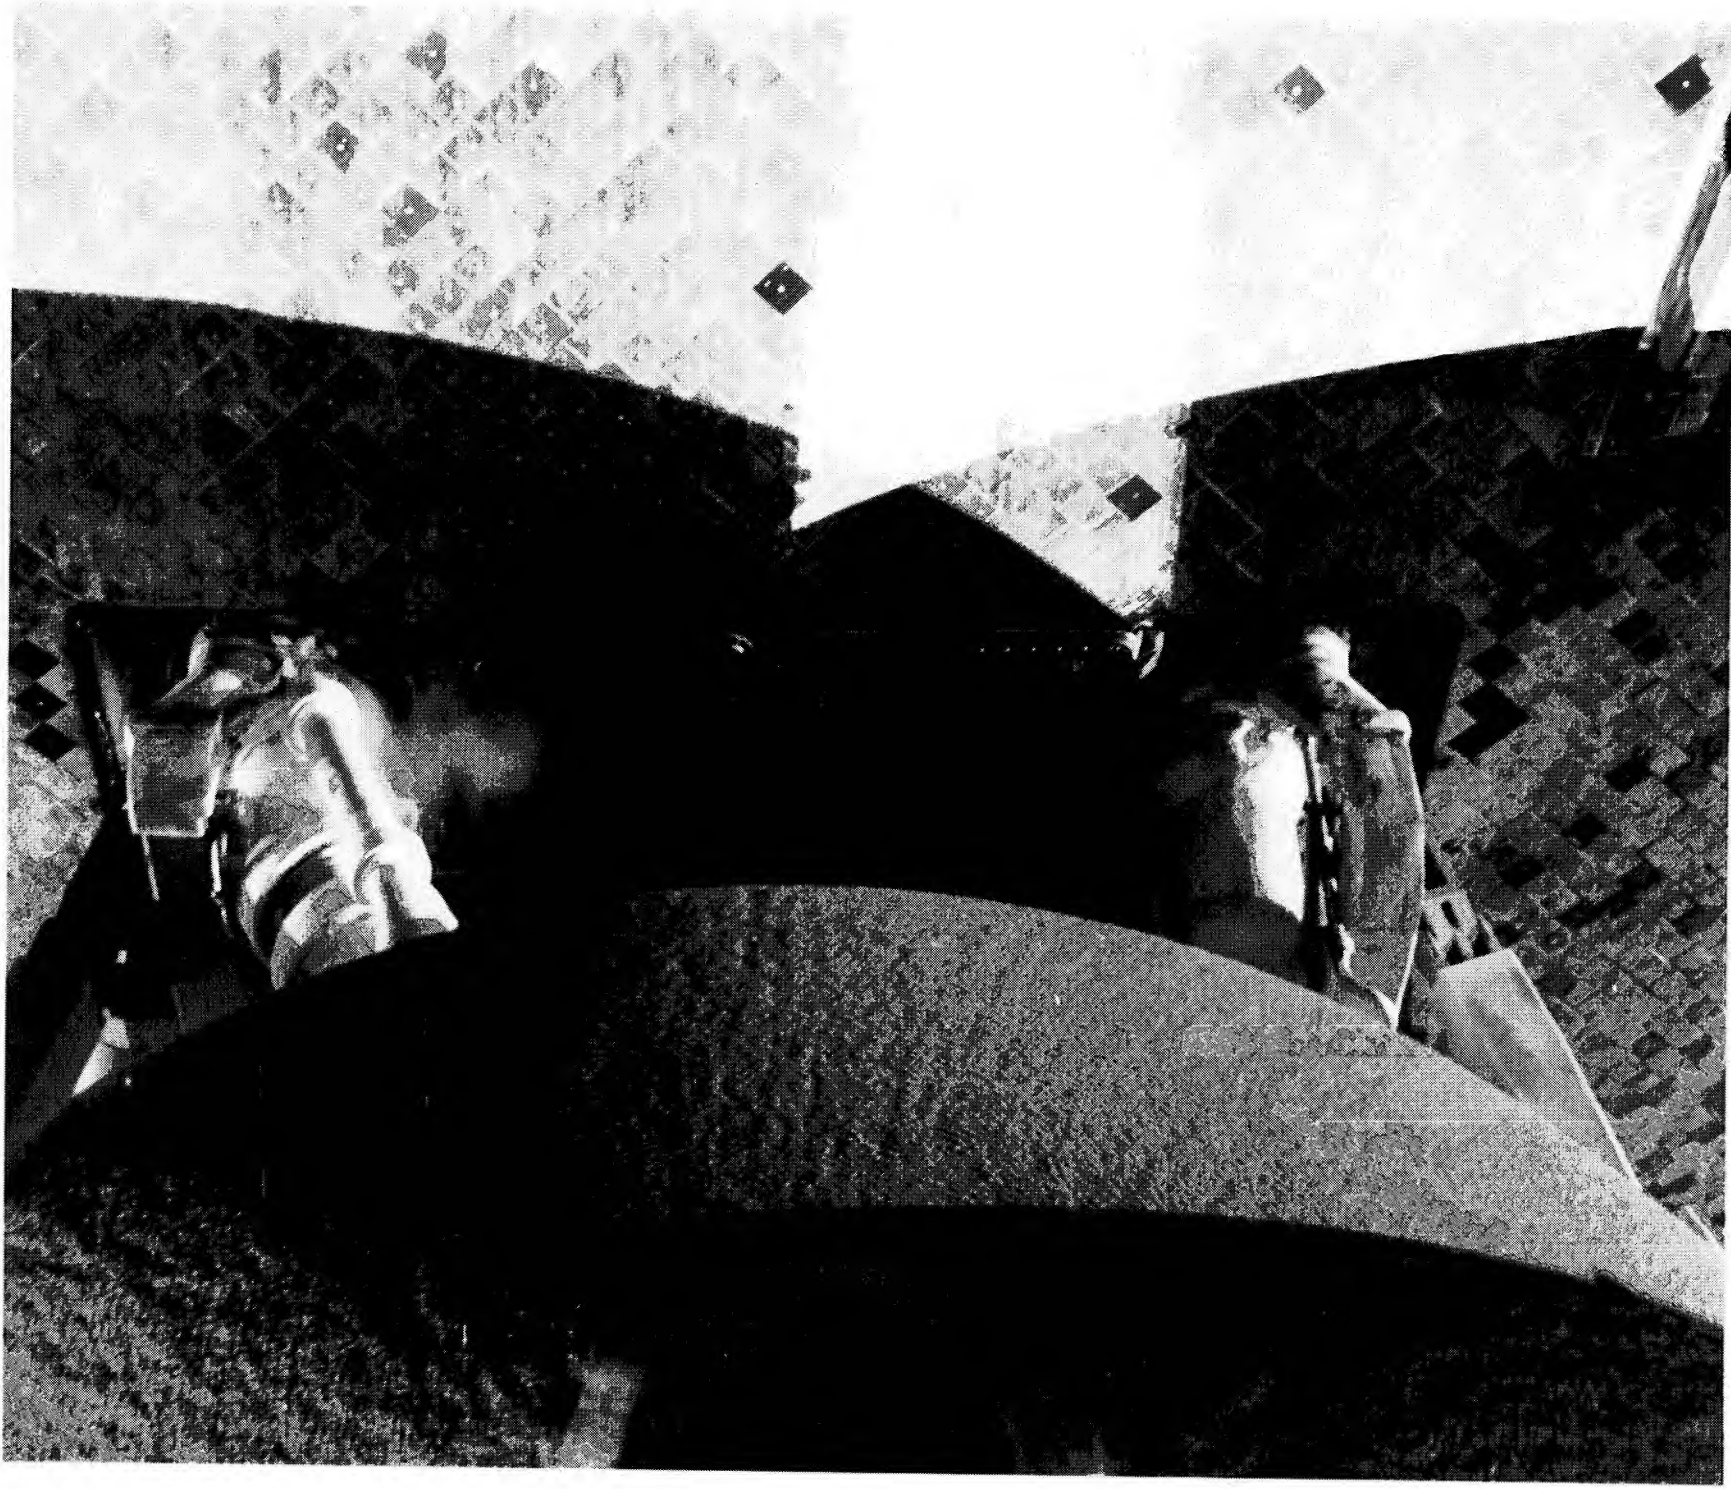
Ice/frost formed on the aft side of the LO2 umbilical, in the  
LH2 recirculation line bellows, and on all purge vents

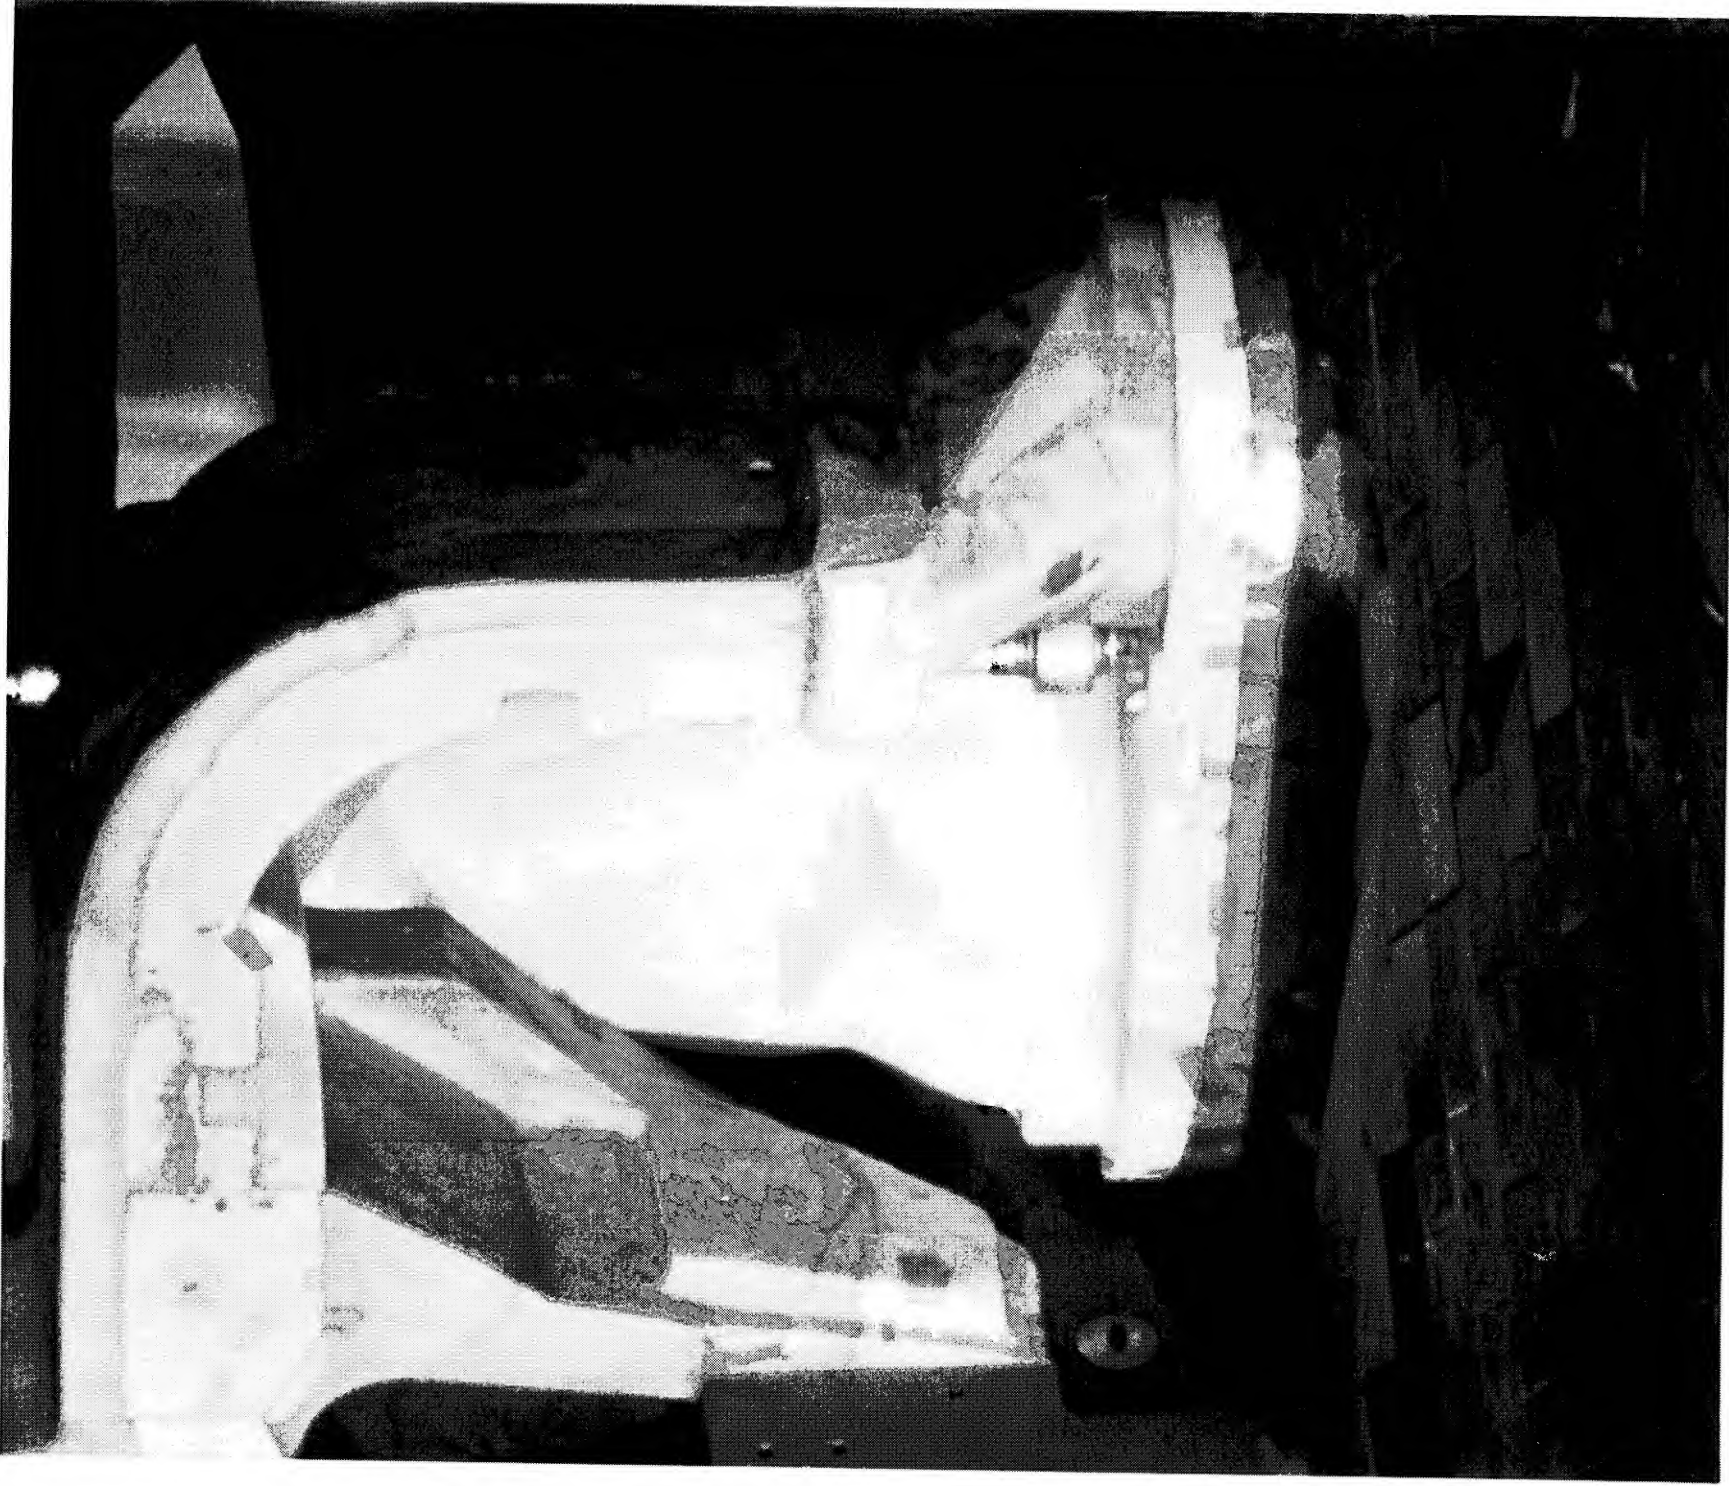
Minimal ice/frost has accumulated on the LO2 ET/ORB umbilical baggie and purge vents. Note condensate drops on the cable tray

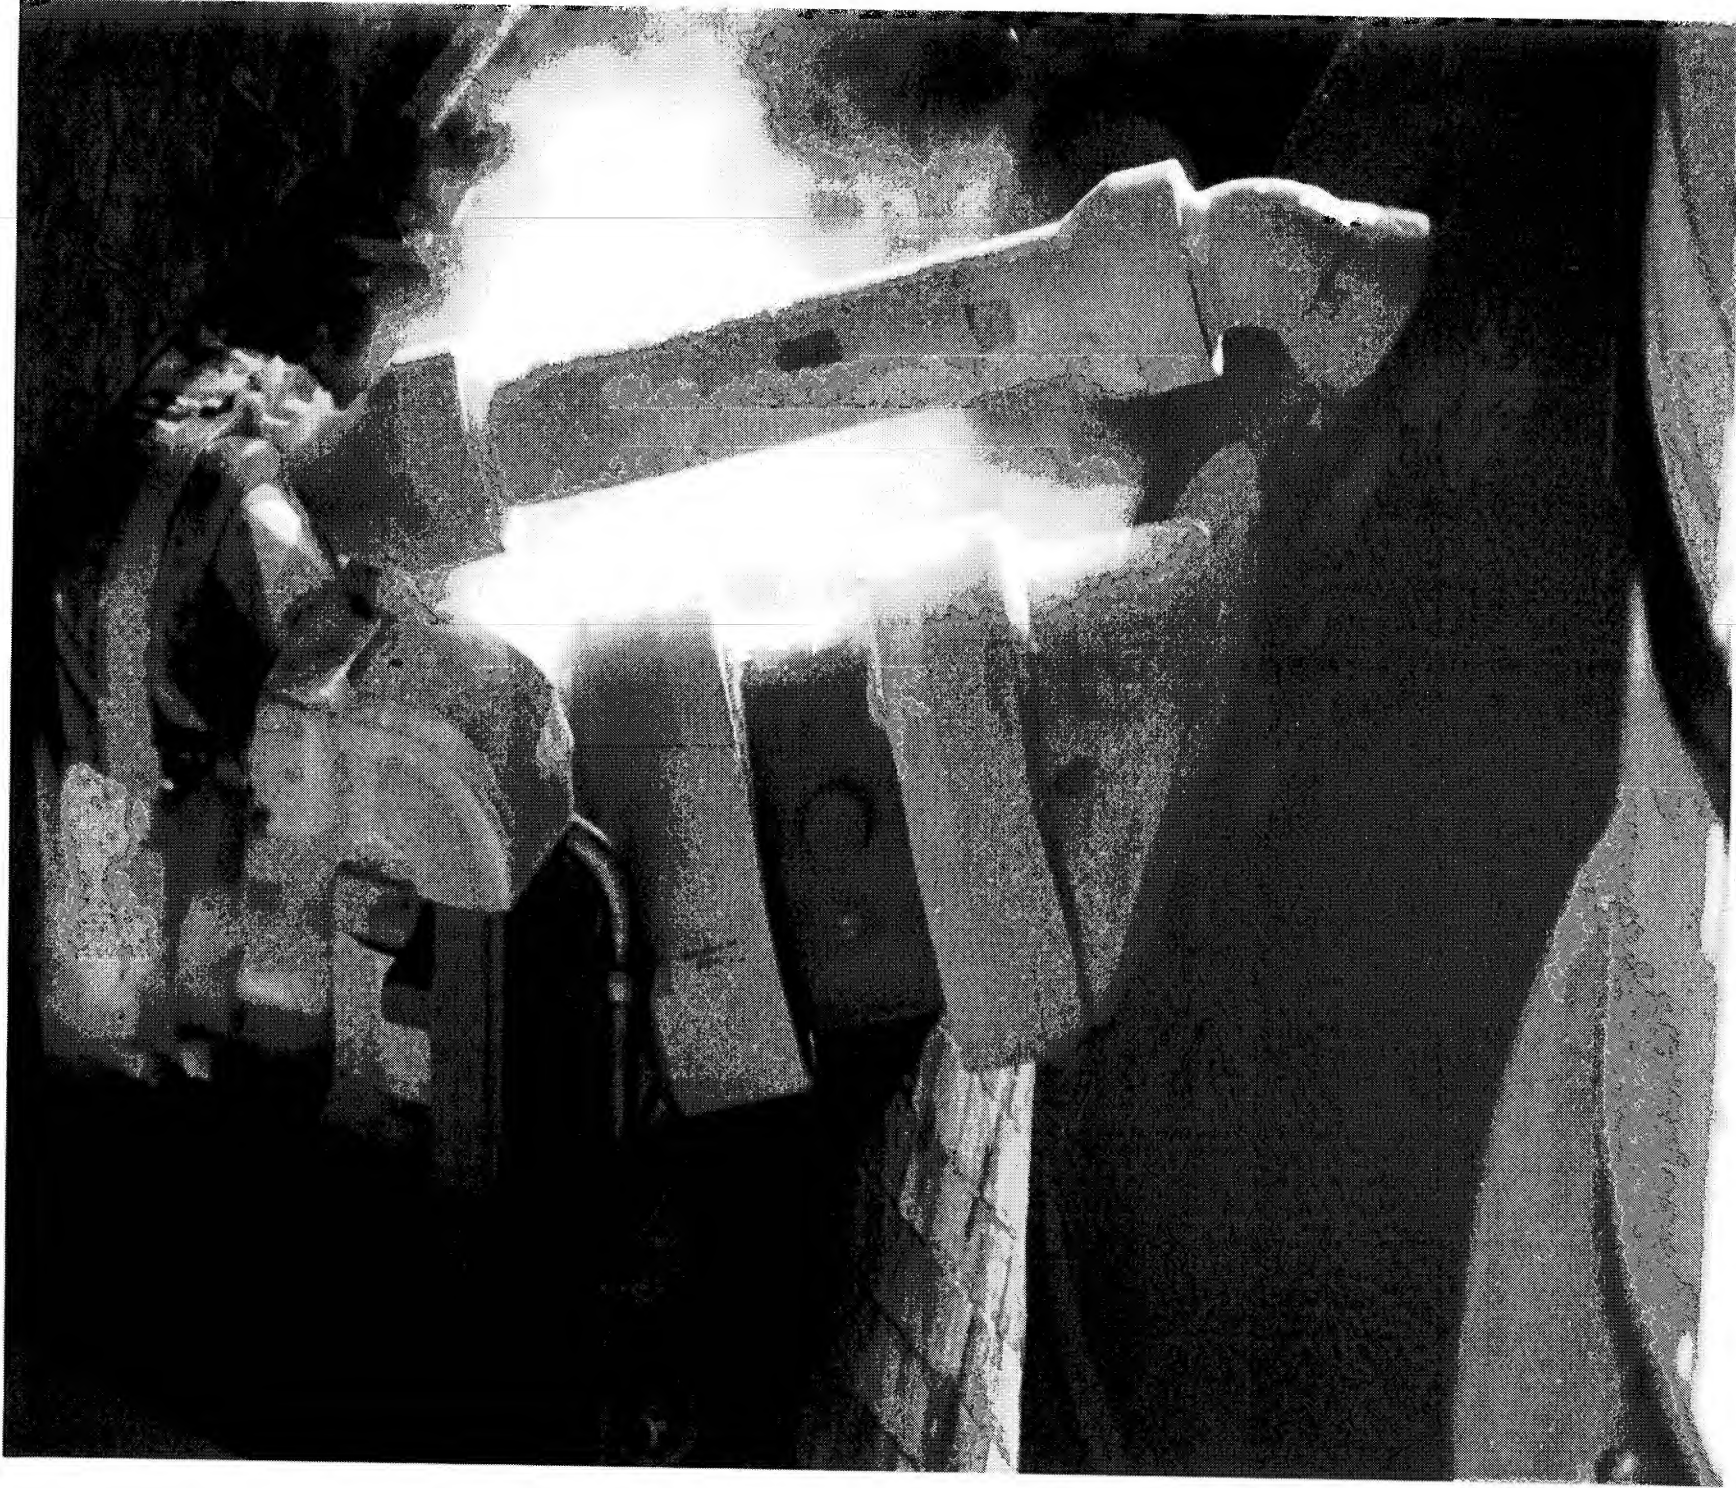
Ice/frost accumulation on the LH2 umbilical baggie, purge vents  
and in the feedline/recirc line bellows is heavier than average

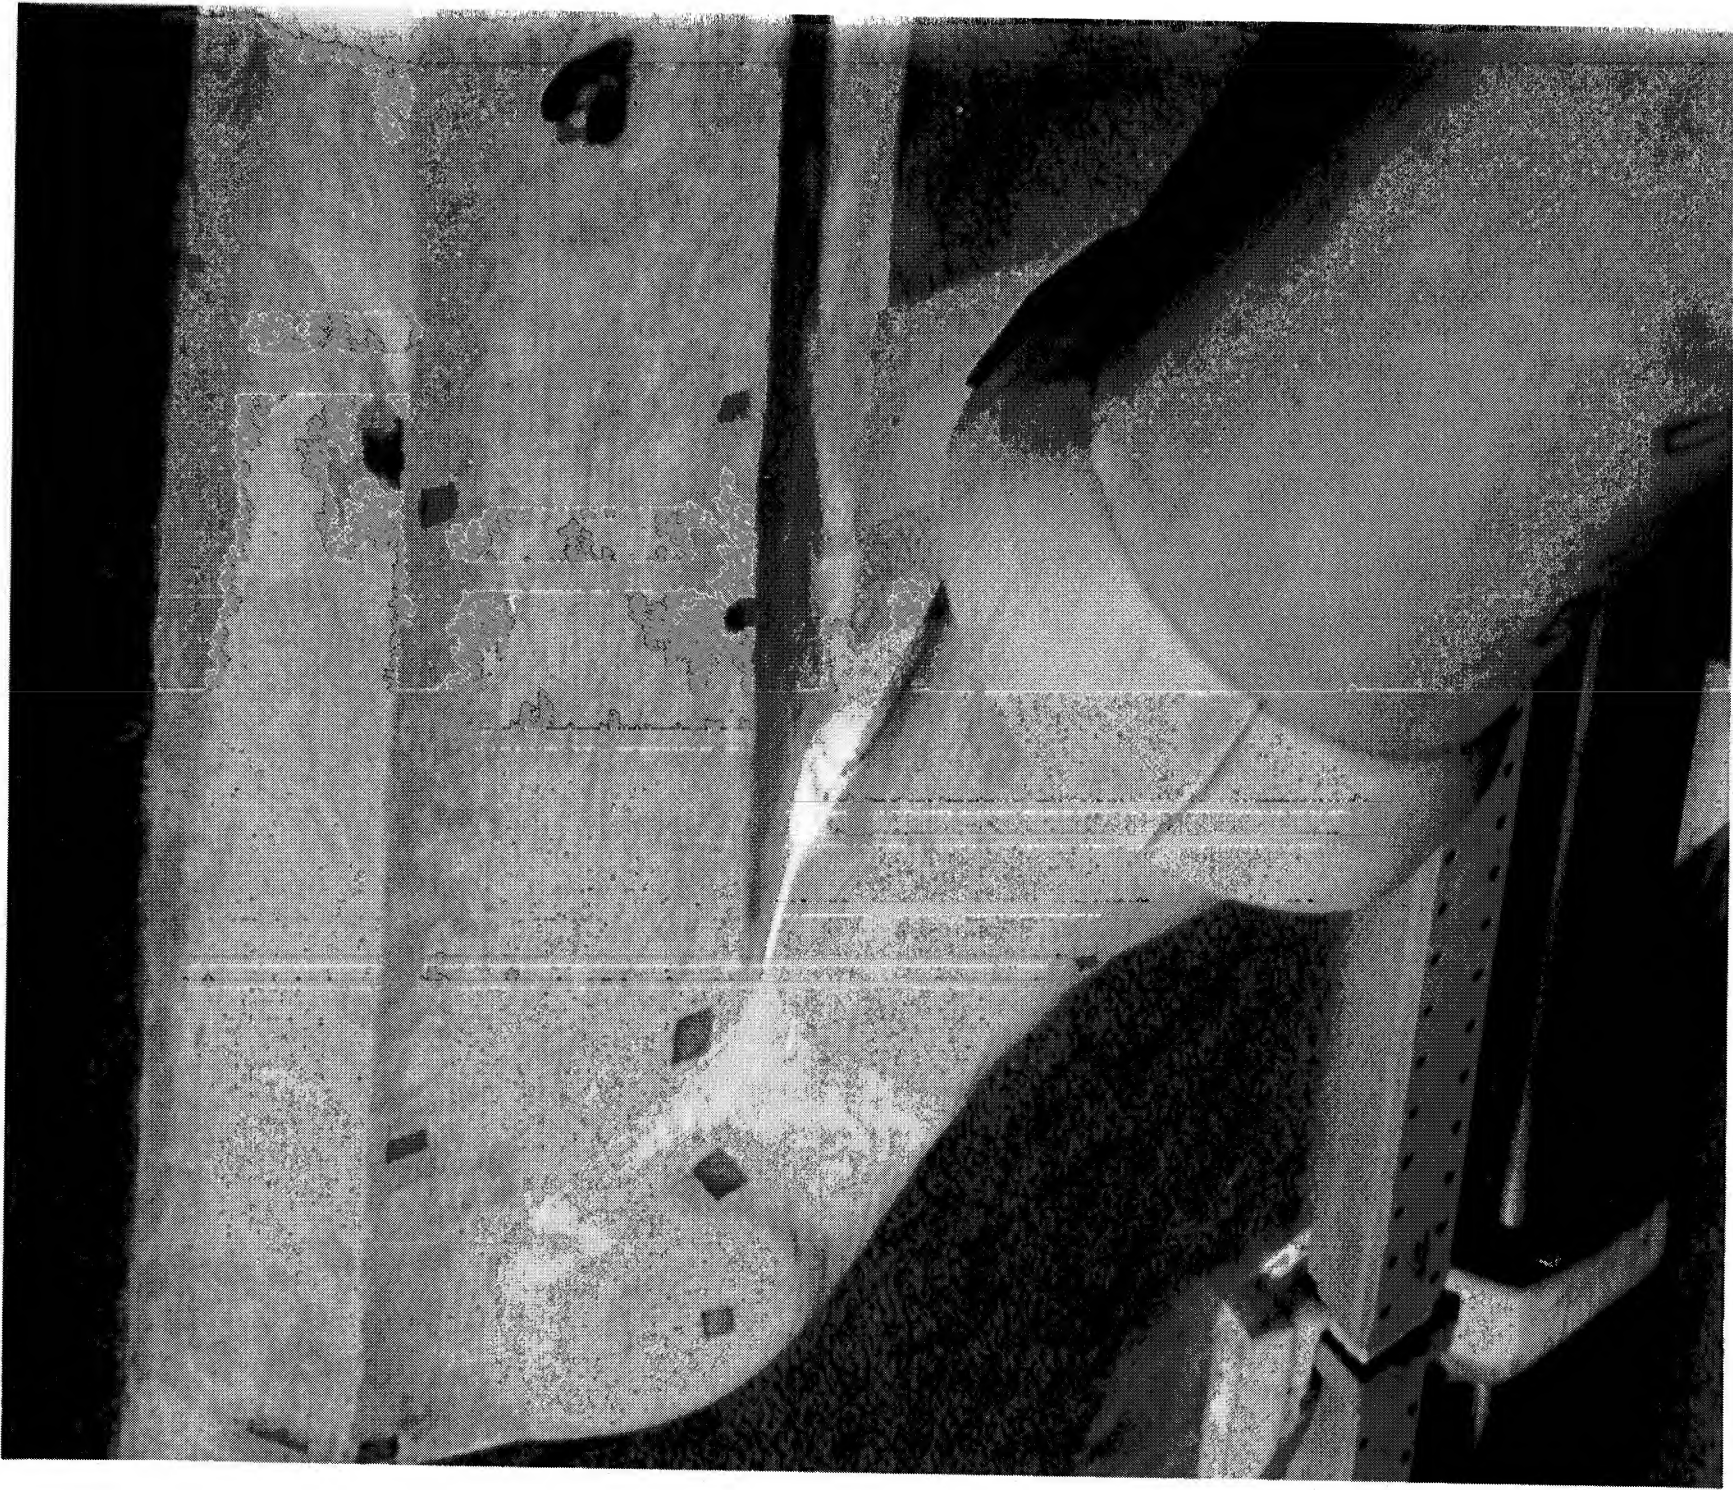
Frost has formed along the cable tray ramp aft side and in a small TPS crack at the longeron-to-thrust strut interface

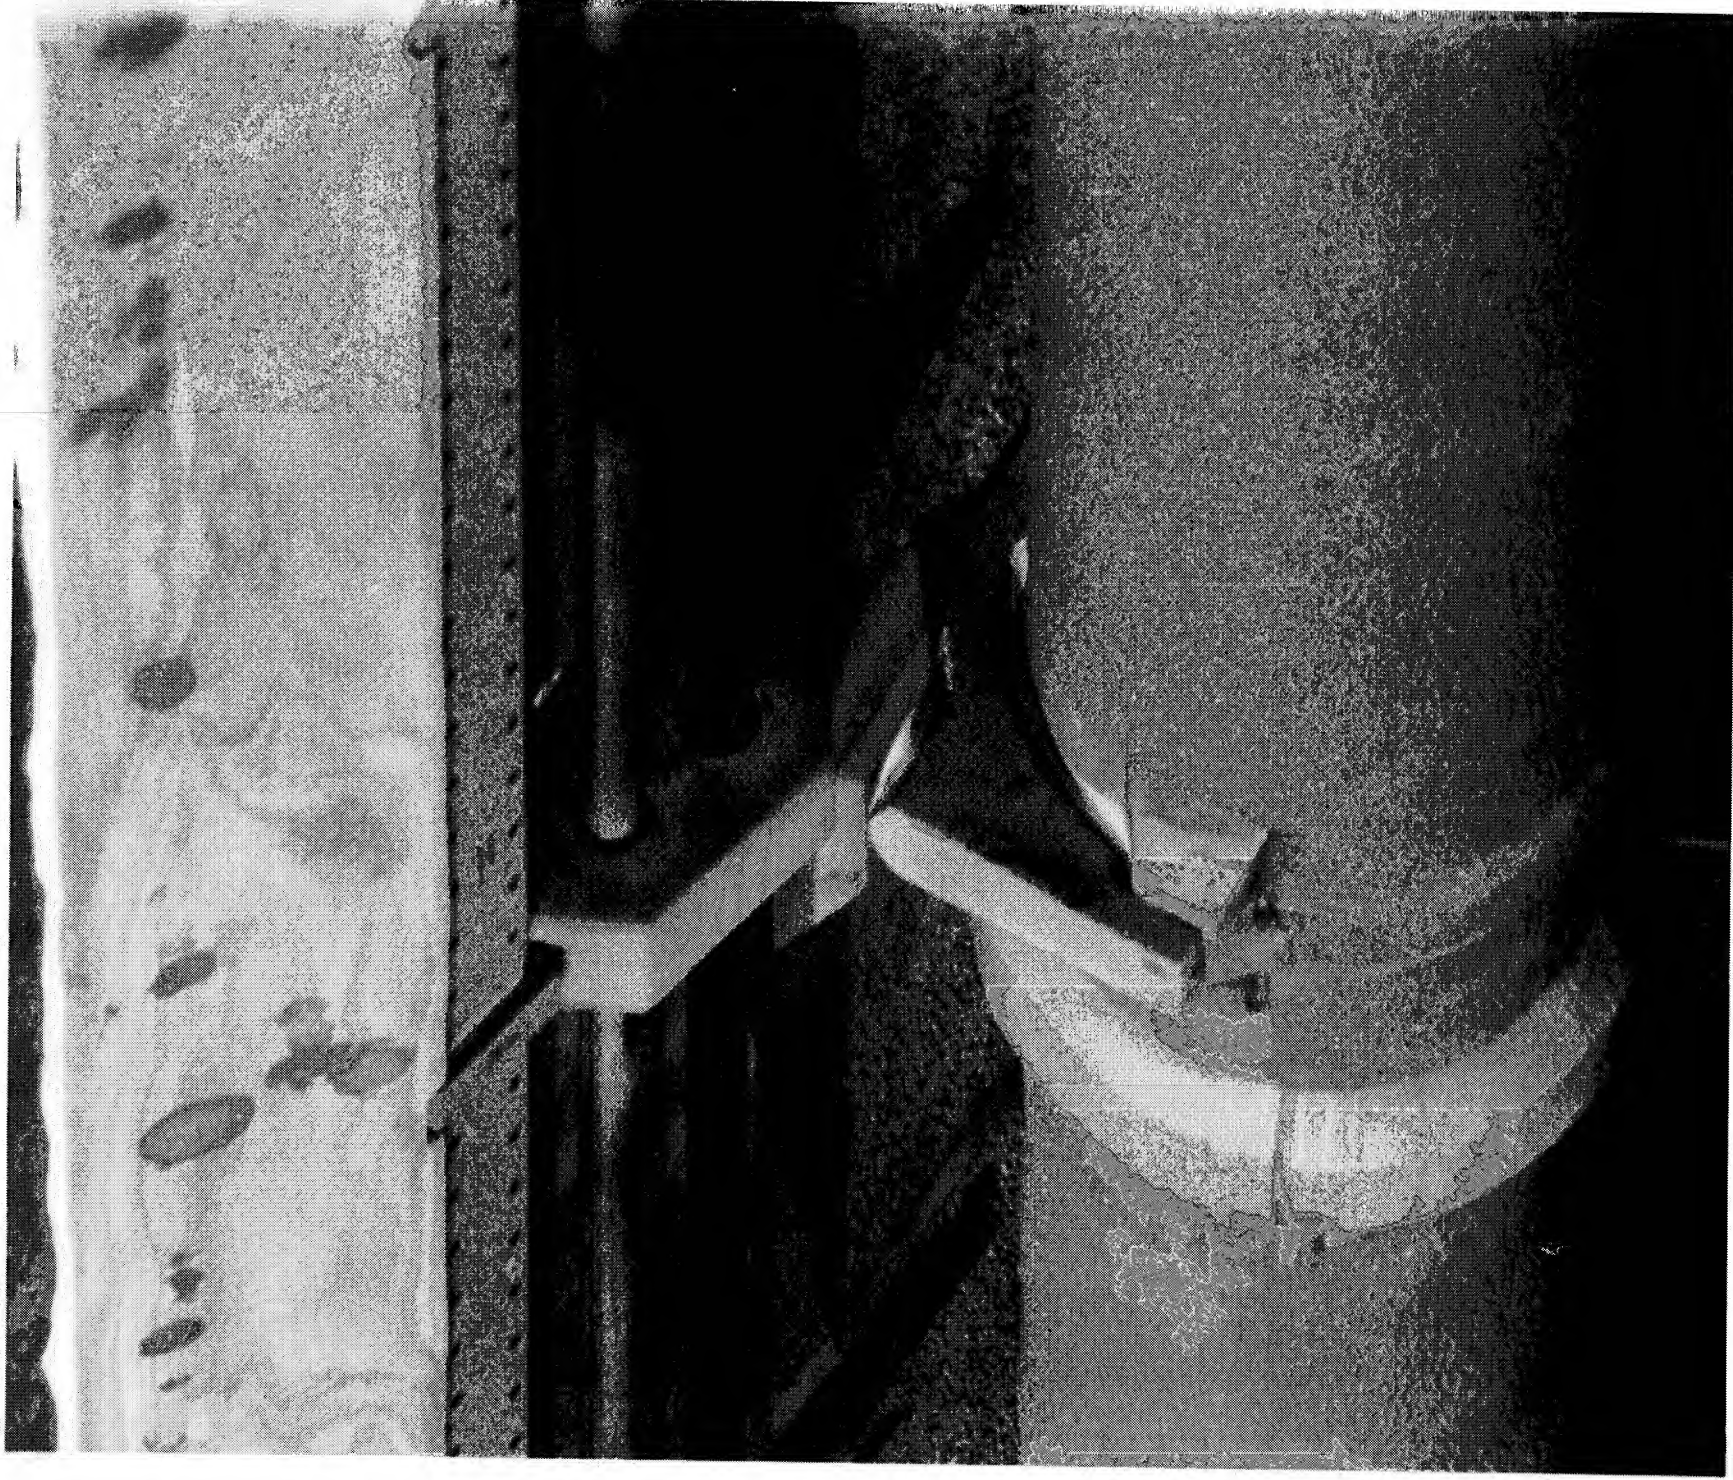
Upper LO2 feedline support brackets were filled with a  
normal accumulation of ice/frost

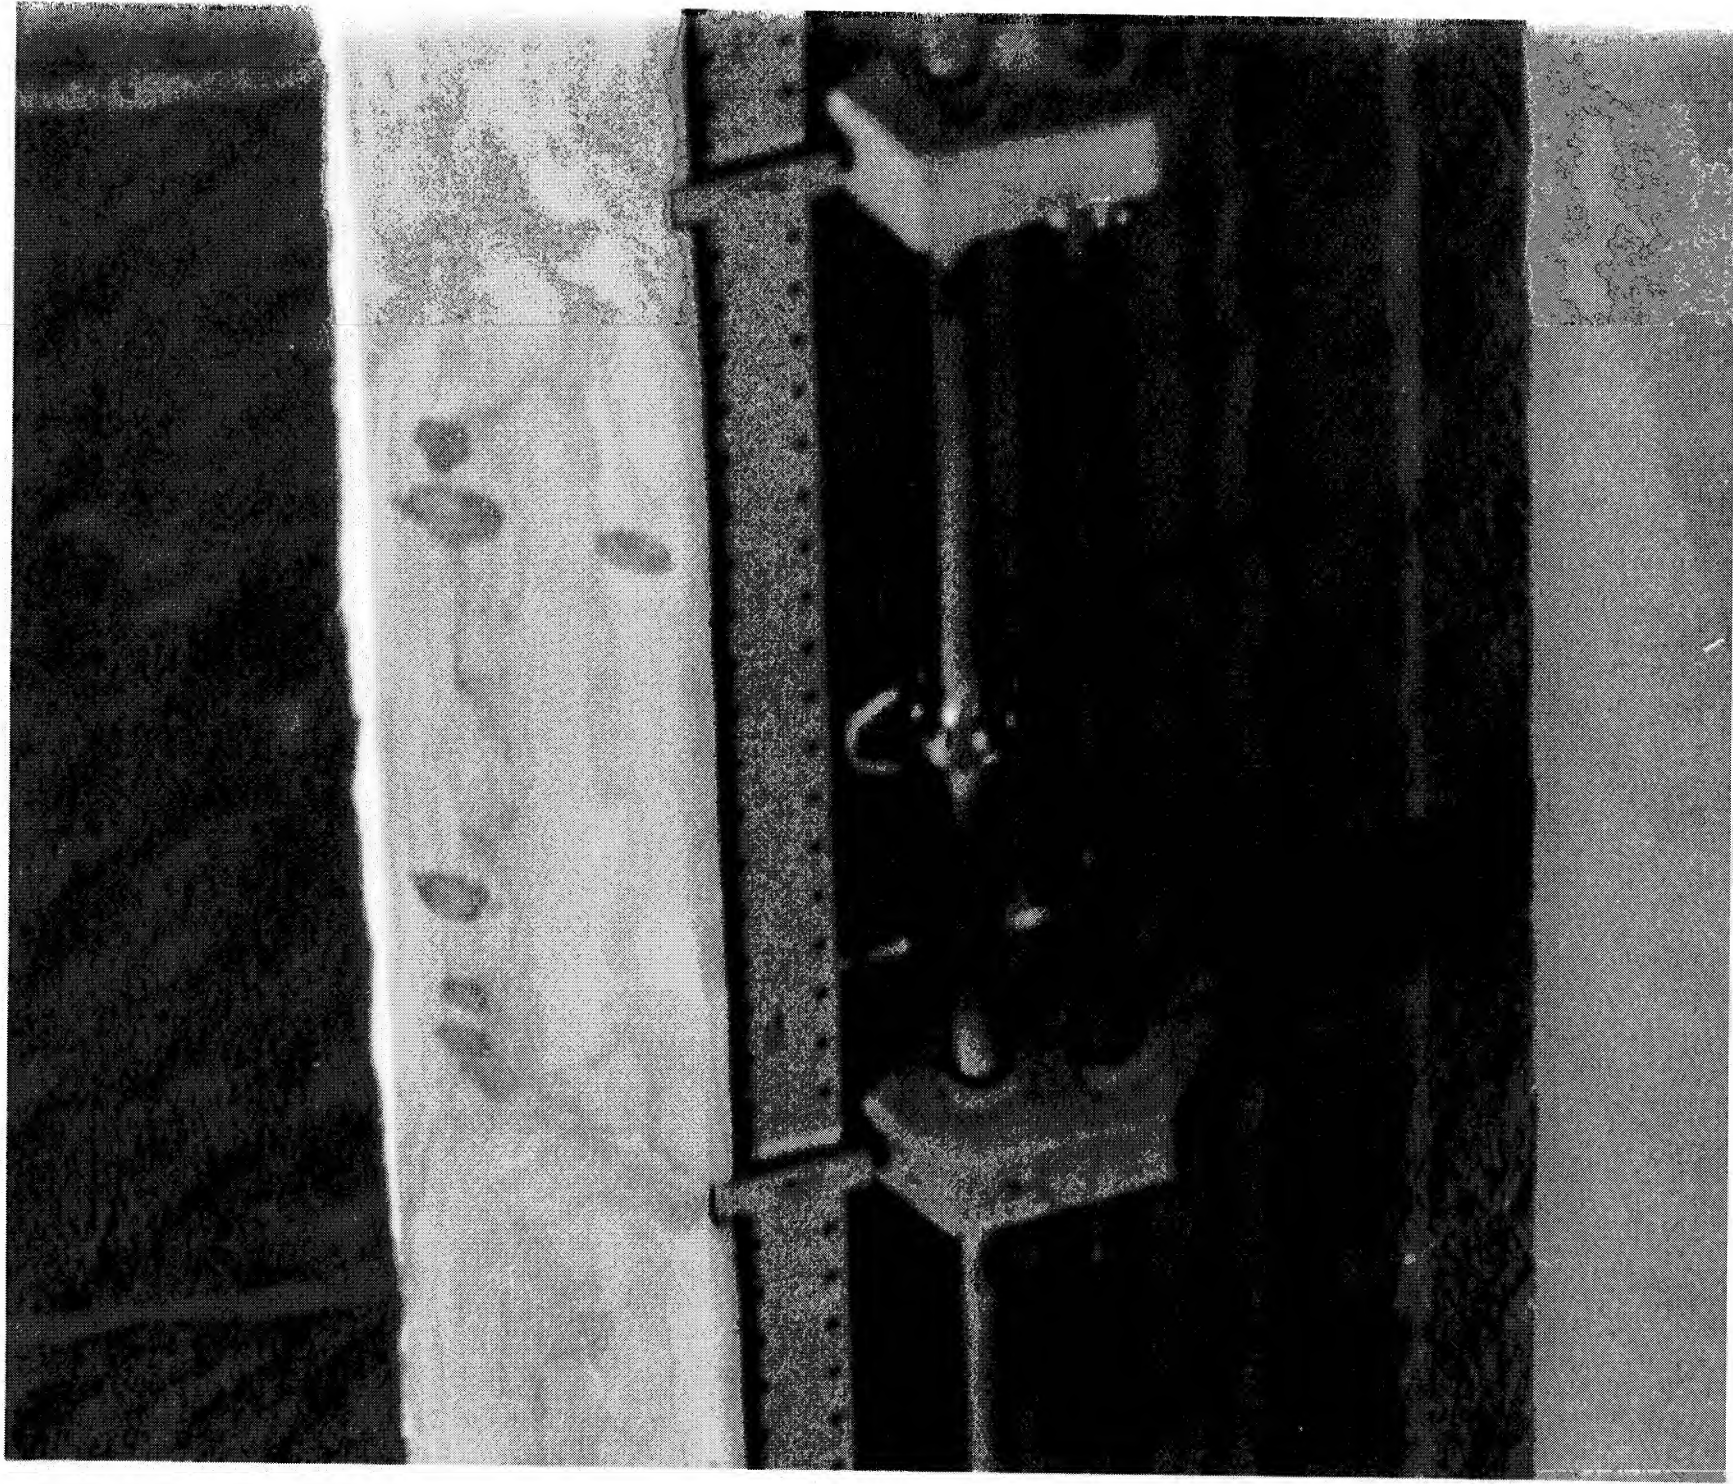
Frost outlines the LH2 tank PAL ramp, pressurization line  
ramps, and a previous 3-inch diameter repair

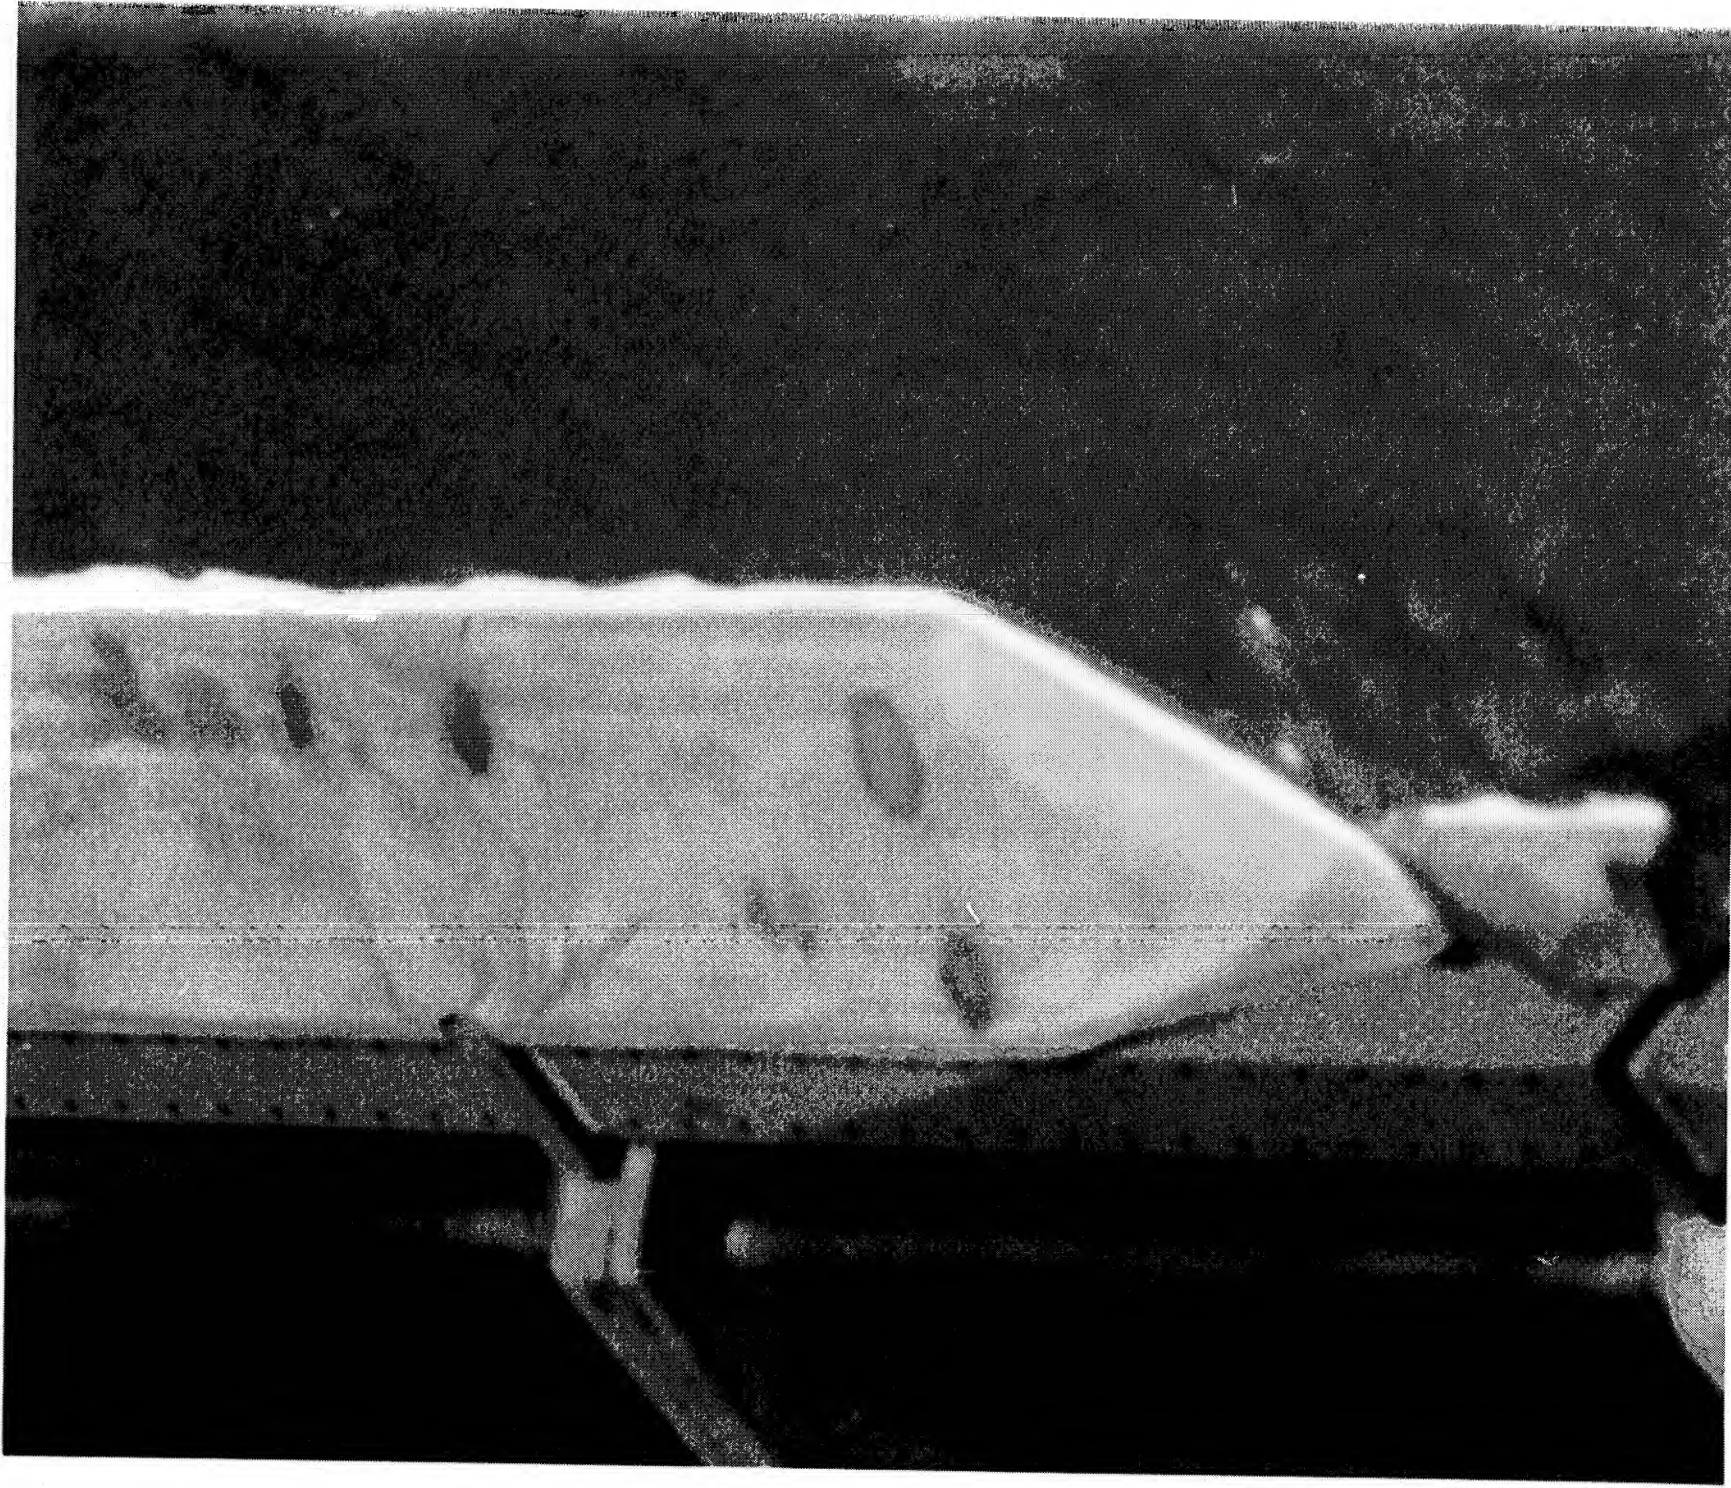
Frost outlines the LH2 tank PAL ramp, a cable tray ramp, and two small sanded areas from previous acreage repairs
